# *Infrared Survey Report*

**Home of:  
Mr. and Mrs. Sample Client  
926 Main Street  
Your Town, USA 12345**

Survey Report #:	PH-081208-2
Survey date:	08-12-08
Thermographer:	Peter Hopkins
Weather:	Sunny
Outdoor temperature:	94 °F
Indoor temperature:	75 °F
Temp diff In-Out ( $\Delta t$ ):	19 F °

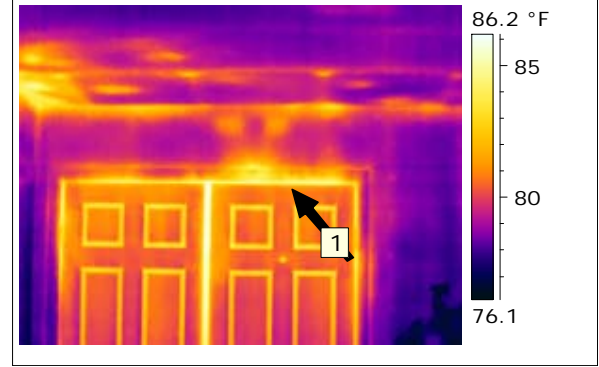
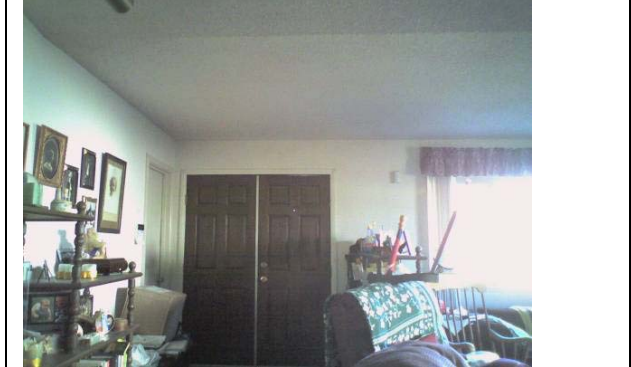
<p>Date 08-12-08</p>	<p>Image.File name IR_1059.jpg</p>
<p>Location: Entry Area          Where: Exterior door          Condition: Weatherstripping at exterior doors appear to have air infiltration from gaps/missing sections.          Recommendation: We recommend further investigation of this area and repair as needed.</p>	
<p>CORRECTED BY: _____ DATE ____-____-_____</p>

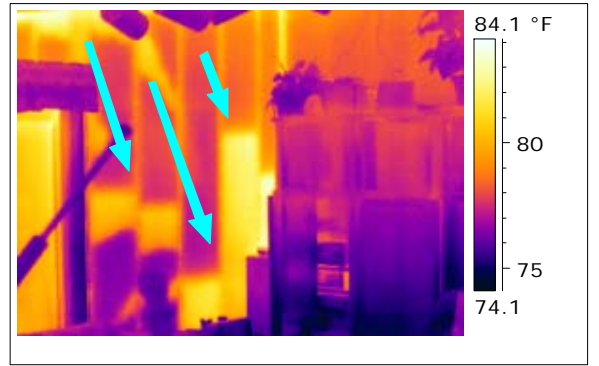
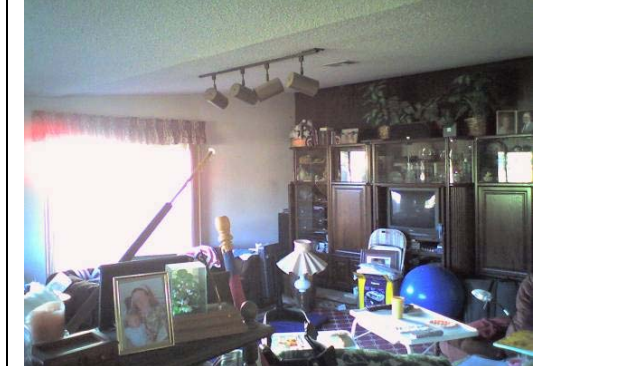
<p>Date 08-12-08</p>	<p>Image.File name IR_1069.jpg</p>
<p>Location: Living Room          Where: Left wall          Condition: Appears to be missing or loose insulation          Recommendation: We recommend further investigation of this area and repair as needed.</p>	
<p>CORRECTED BY: _____ DATE ____-____-_____</p>

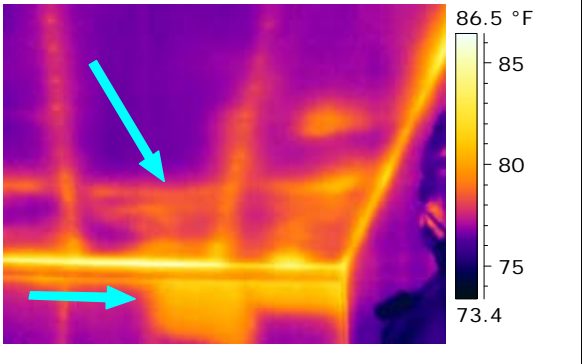
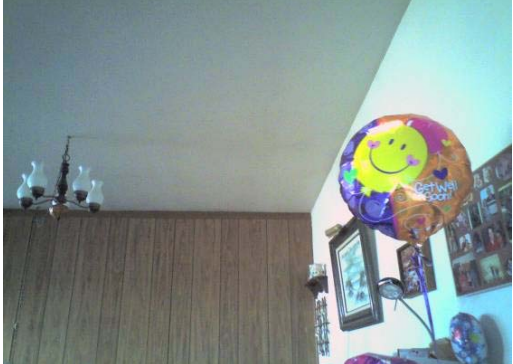
<p>Date 08-12-08</p>	<p>Image.File name IR_1075.jpg</p>
<p>Location: Kitchen          Where: Ceiling          Condition: Appears to be missing or loose insulation          Recommendation: We recommend further investigation of this area and repair as needed.</p>	
<p>CORRECTED BY: _____ DATE ____-____-____</p>

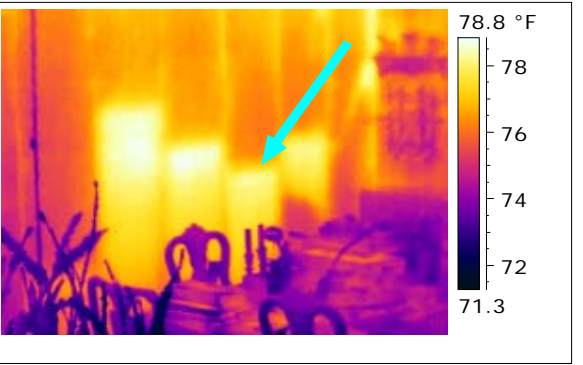
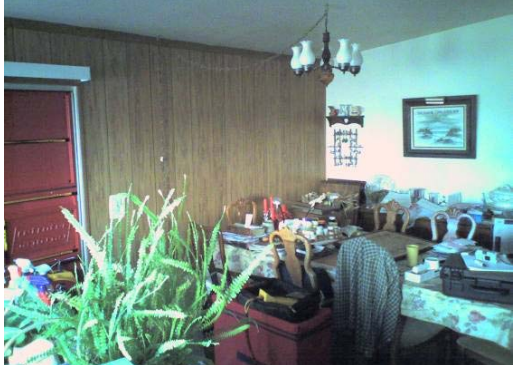
<p>Date 08-12-08</p>	<p>Image.File name IR_1079.jpg</p>
<p>Location: Kitchen          Where: Rear wall          Condition: Appears to be missing or loose insulation          Recommendation: We recommend further investigation of this area and repair as needed.</p>	
<p>CORRECTED BY: _____ DATE ____-____-____</p>

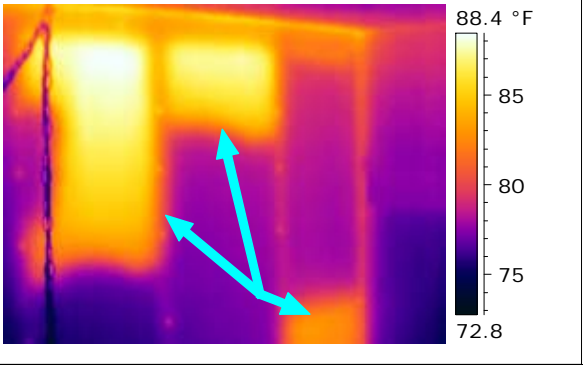
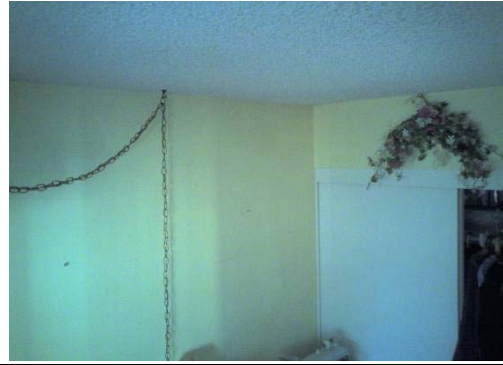
<p>Date 08-12-08</p>	<p>Image.File name IR_1099.jpg</p>
<p>Location: Guest Bedroom 2          Where: Right wall (top)          Condition: Appears to be missing or loose insulation          Recommendation: We recommend further investigation of this area and repair as needed.</p>	
<p>CORRECTED BY: _____ DATE ____-____-_____</p>

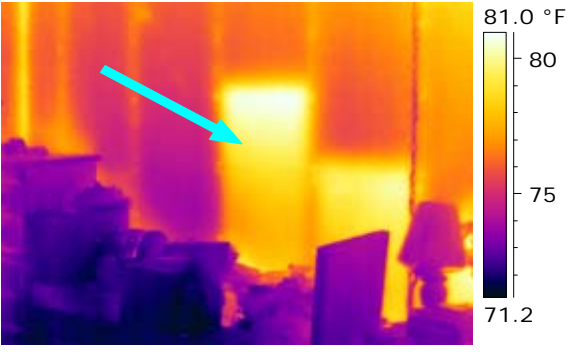
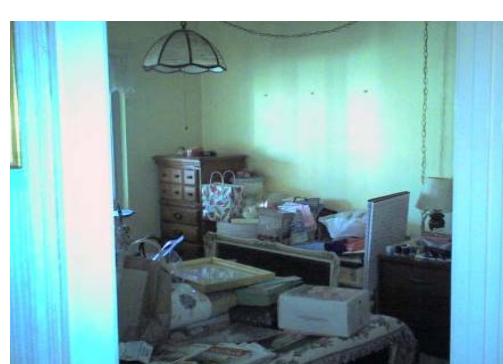
<p>Date 08-12-08</p>	<p>Image.File name IR_1103.jpg</p>
<p>Location: Guest Bedroom 2          Where: Right wall (bottom)          Condition: Appears to be missing or loose insulation          Recommendation: We recommend further investigation of this area and repair as needed.</p>	
<p>CORRECTED BY: _____ DATE ____-____-_____</p>

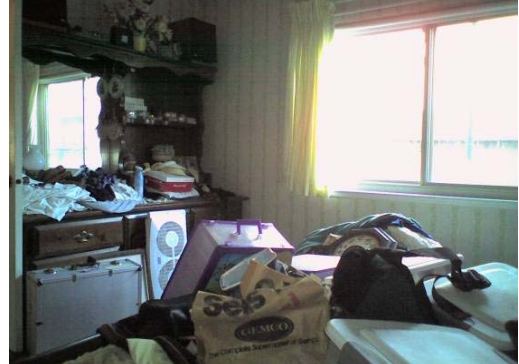
Date 08-12-08	Image.File name IR_1109.jpg
<p>Location: Master Bedroom          Where: Right wall          Condition: Appears to be missing or loose insulation          Recommendation: We recommend further investigation of this area and repair as needed.</p>	
<p>CORRECTED BY: _____ DATE ____-____-_____</p>

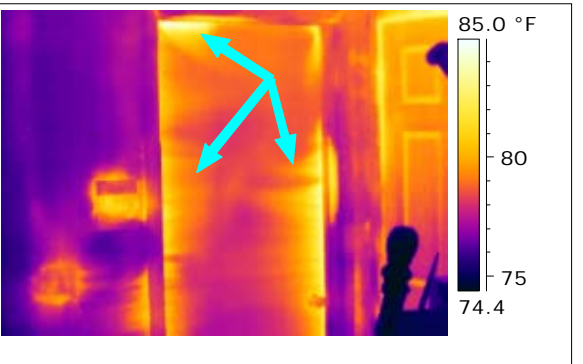
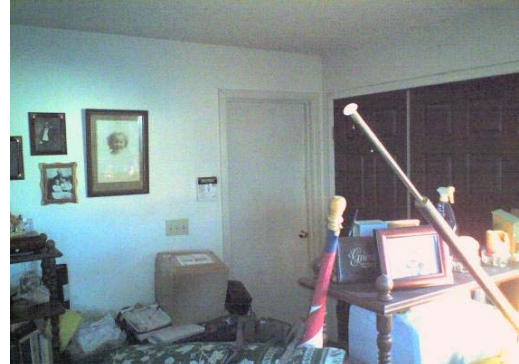
Date 08-12-08	Image.File name IR_1119.jpg
<p>Location: Living Room          Where: Garage passage door          Condition: Air leakage noted during blower door test          Recommendation: We recommend proper weatherstripping at all exterior doors.</p>	
<p>CORRECTED BY: _____ DATE ____-____-_____</p>

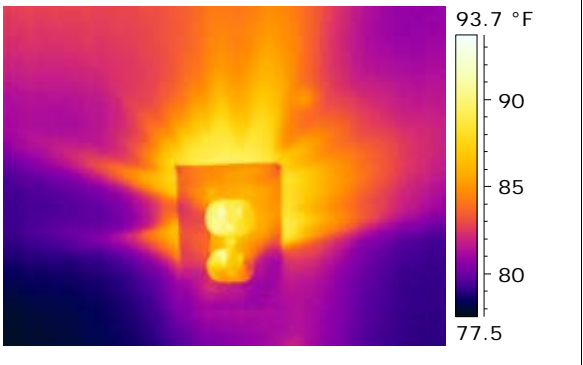
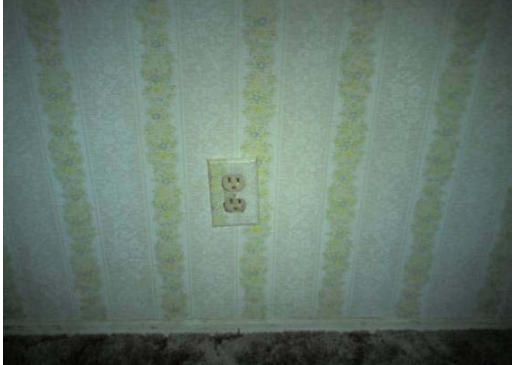
Date 08-12-08	Image.File name IR_1131.jpg
<p>Location: General image          Where: Common throughout home          Condition: Air infiltration at outlets &amp; switches          Recommendation: We recommend a proper gasket or caulking as needed to help prevent air infiltration.</p>	
<p>CORRECTED BY: _____ DATE ____-____-_____</p>

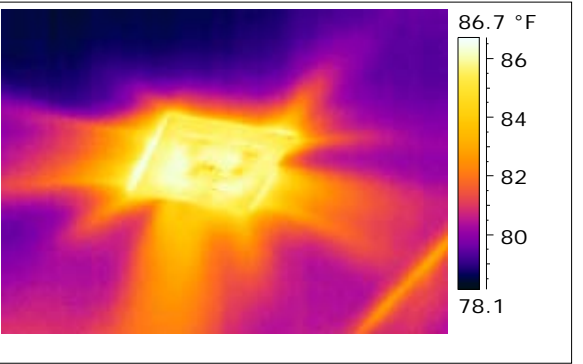
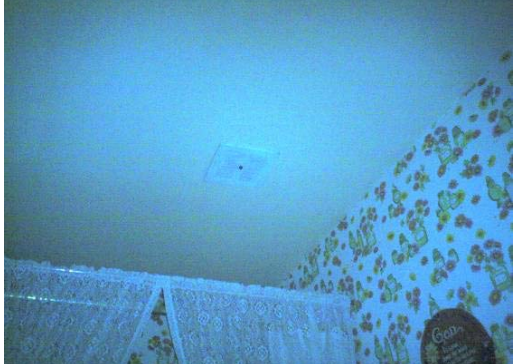
Date 08-12-08	Image.File name IR_1137.jpg
<p>Location: General Light fixtures          Where: Throughout residence at ceiling fixtures          Condition: Air infiltration          Recommendation: We recommend proper gaskets or caulking to help prevent air infiltration.</p>	
<p>CORRECTED BY: _____ DATE ____-____-_____</p>
